Character-Defining Features of Contributing Buildings and Structures in the Fort Gordon, Georgia, Signal School Campus Historic District

Sunny E. Adams and Adam D. Smith

July 2016

Under Project 450904, "NHPA Building Evaluations at Fort Gordon"

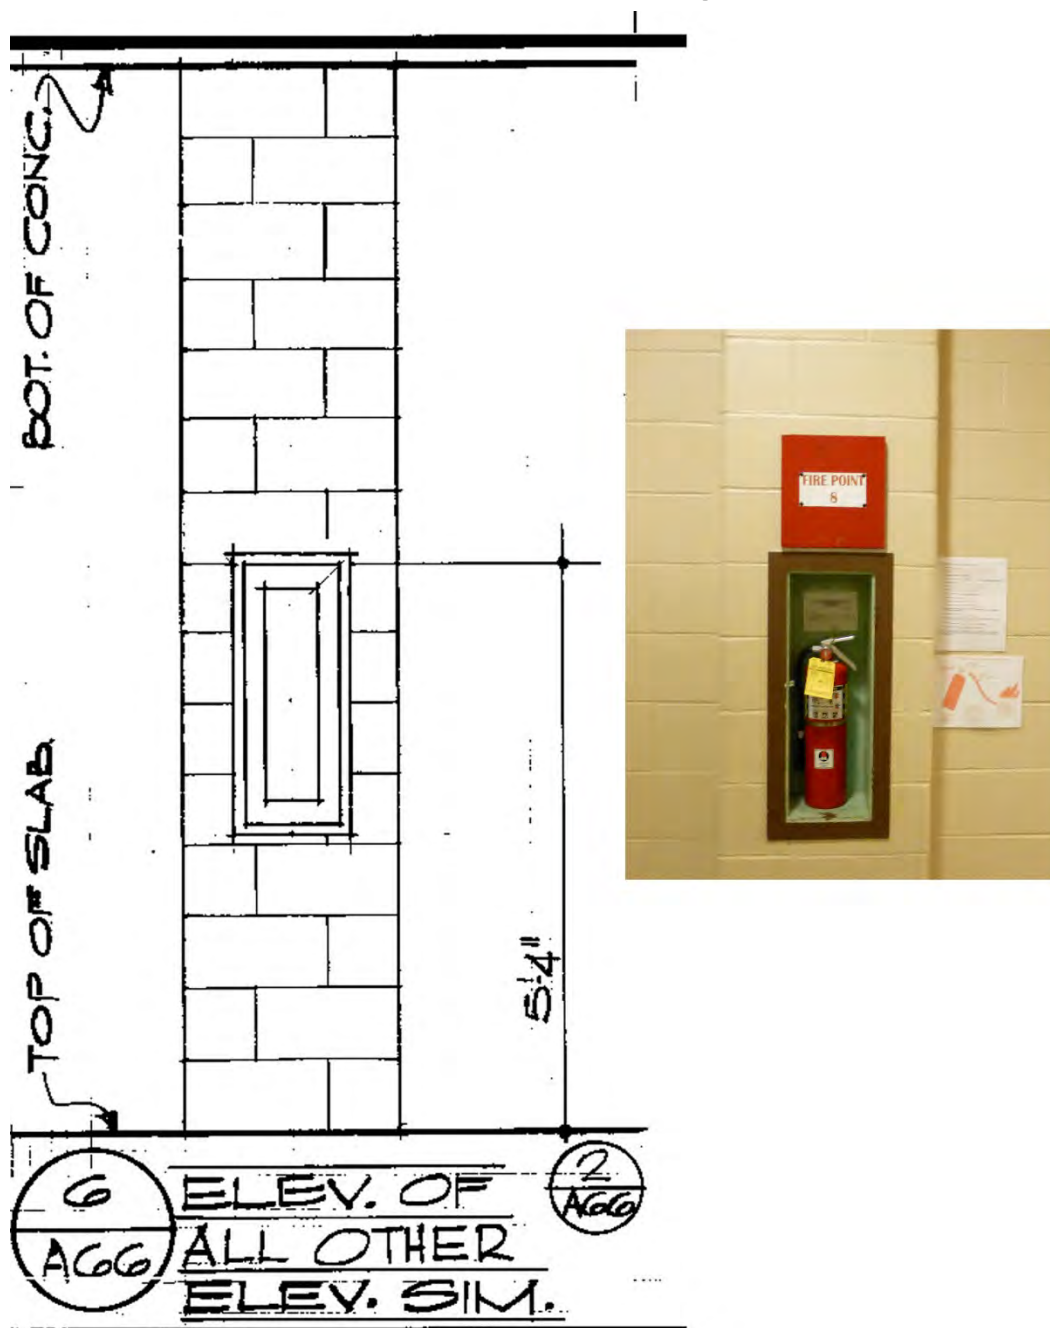
Figure 169. Fire hydrant display case, comparison of the original drawing from 1964 [left] to the current condition of the display case [right] (ERDC-CERL, 2015).

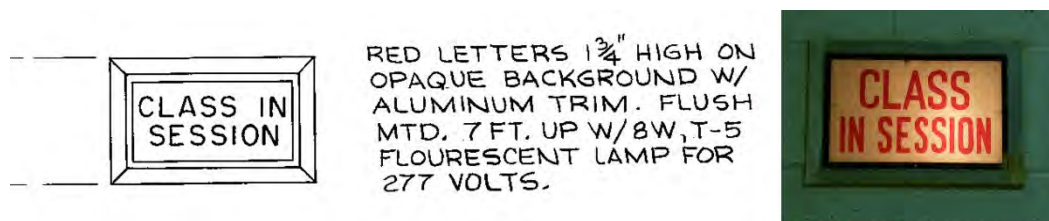
Figure 173. Class in session sign – comparison of the original drawing [left] to the current condition of the sign located in the Signal School classroom buildings [right] (ERDC-CERL, 2015).

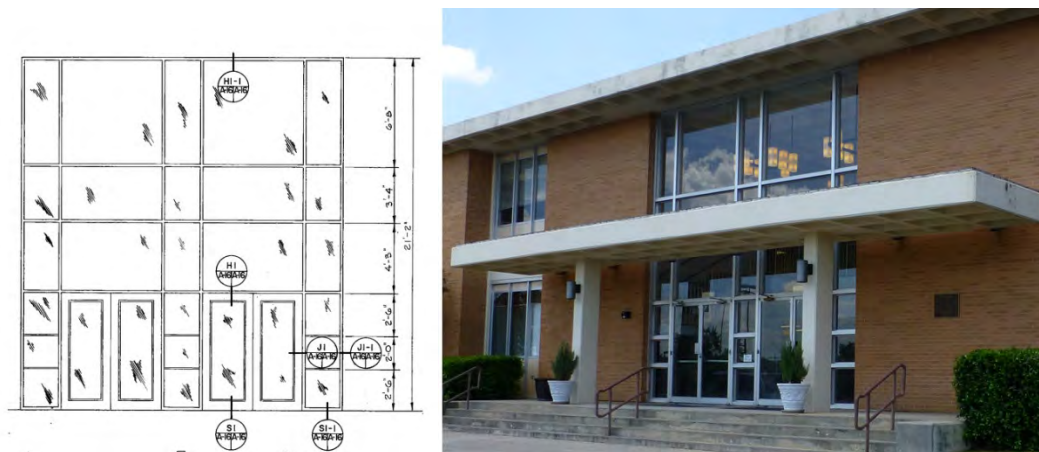
Figure 185. Main entry on the south elevation – comparison of the original drawing detail from 1973 [left] to the current condition of the bright-aluminum and plate-glass windows and doors [right] (ERDC-CERL, 2015).

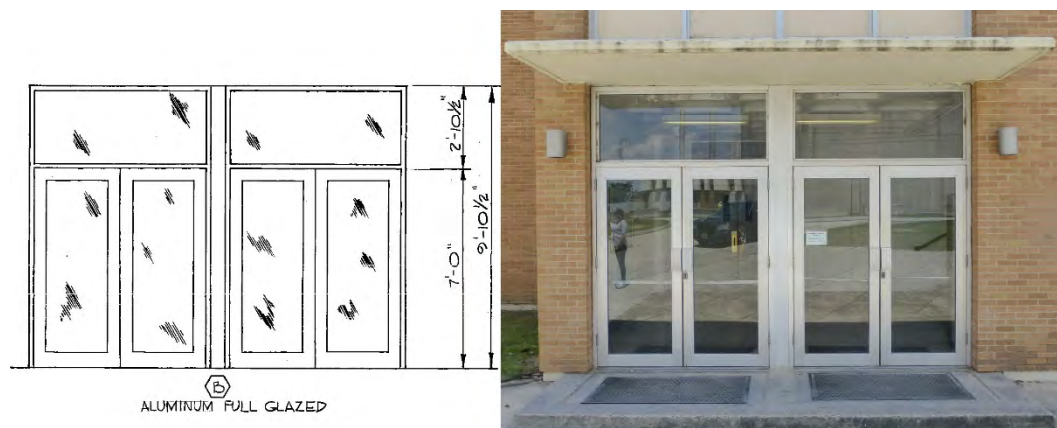
Figure 186. Paired entry doors with concrete canopy – comparison of the original drawing detail from 1973 [left] to the current condition of the bright-aluminum and plate-glass doors [right] (ERDC-CERL, 2015).

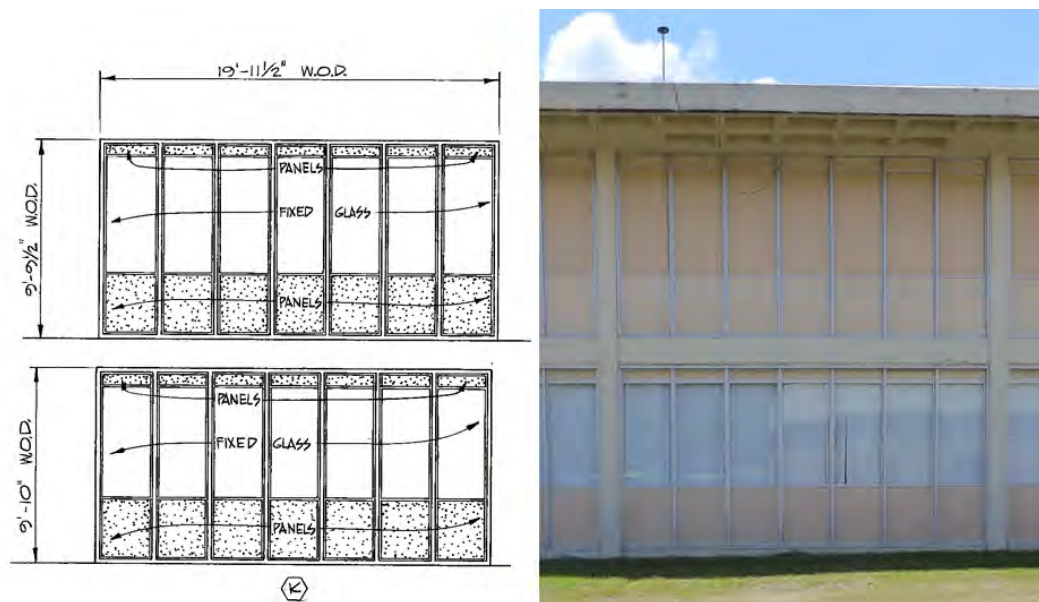
Figure 187. Large group of windows and panel inserts on the northwest elevation of the north wing – comparison of the original drawing detail from 1973 [left] to the current condition of the bright-aluminum fixed windows and panel inserts on the first floor and the modified window openings with newer panel inserts [right] (ERDC-CERL, 2015).

Listed below are character-defining features of Building 29801, Nelson Hall that have been removed or replaced over the years; as future renovations occur, these need to be replaced with elements that replicate the original character-defining features of the building. The original drawing will guide this process in coordination with the GA SHPO.

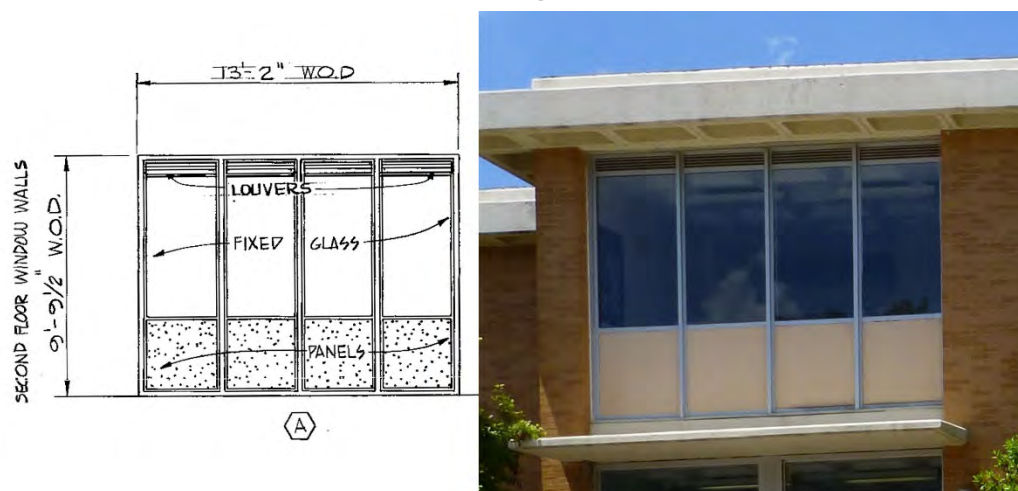
Figure 188. Second-floor windows - Comparison of the original drawing detail from 1973 [left] to the current condition of the bright-aluminum fixed windows and panel inserts on the second floor [right] (ERDC-CERL, 2015).

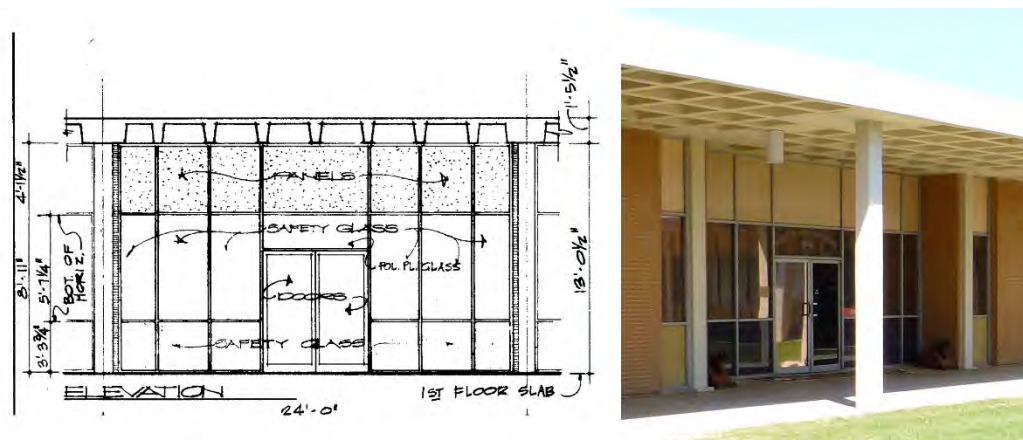
Figure 255. Main entry on the east elevation – comparison of the original drawing detail from 1966 [left] to the current condition of the bright-aluminum and plate-glass entry doors, bright aluminum framed windows and insulated panels [right] (ERDC-CERL, 2015).

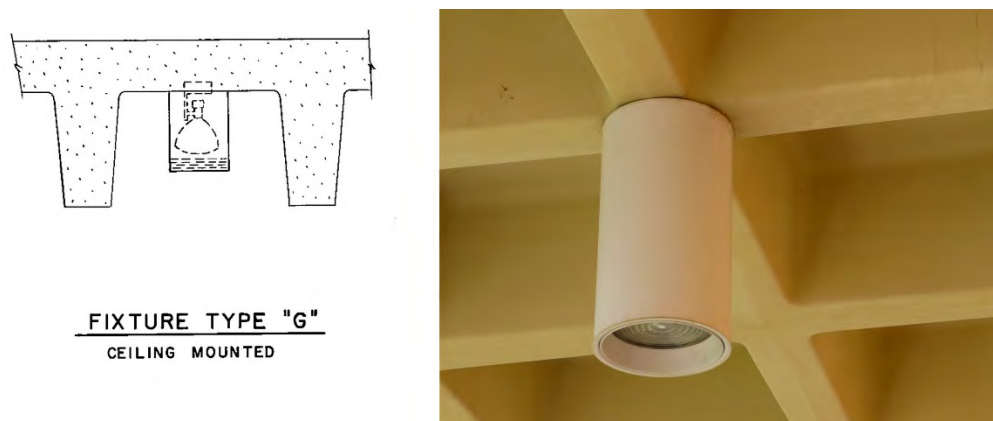
Figure 256. Ceiling-mounted light fixture – comparison of the original drawing detail from 1966 [left] to the current condition of the ceiling-mounted light fixture under the concrete waffle canopy [right] (ERDC-CERL, 2015).

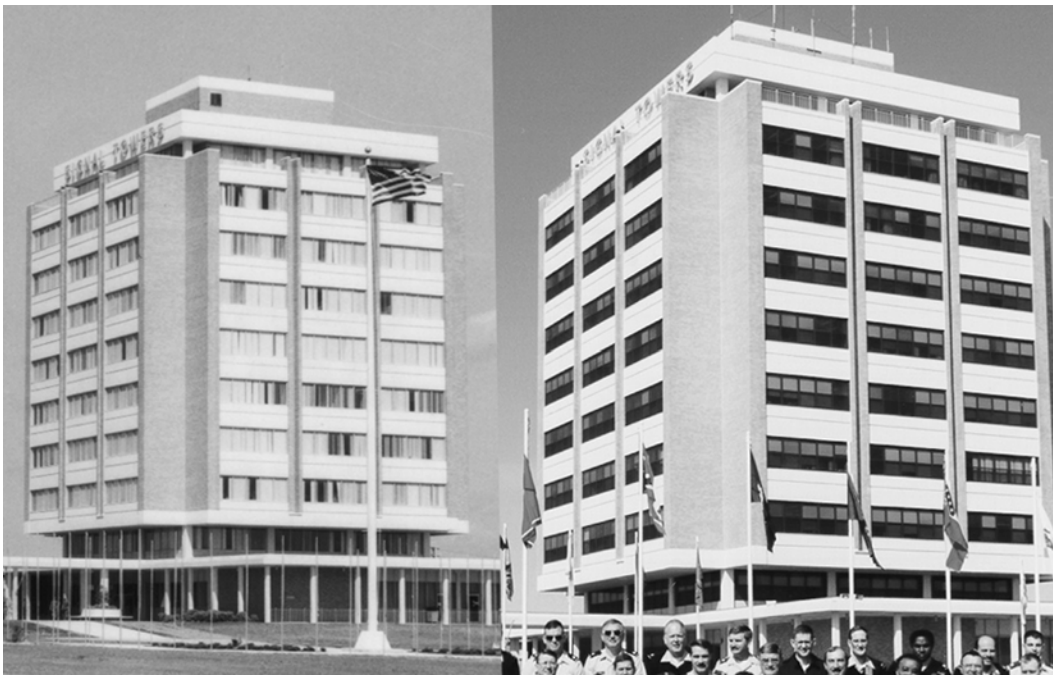
- Windows – original bright-aluminum sash windows on floors 2–11 have been removed and replaced with one-over-one anodized-bronze aluminum windows/
- Metal handrails – some have been removed around the perimeter of the covered walkway.
- Most of the original features in the lobby design have been removed over the years.

Figure 268. Building 29808, Signal Towers, comparison of the original windows [left] and the replacement windows [right] (Signal Corps Historian Office).

Listed below are character-defining features of Building 29808, Signal Towers, that have been removed or replaced over the years; as future renovations occur, these need to be replaced with elements that replicate the original character-defining features of the building. The historic photograph will guide this process in coordination with the GA SHPO.

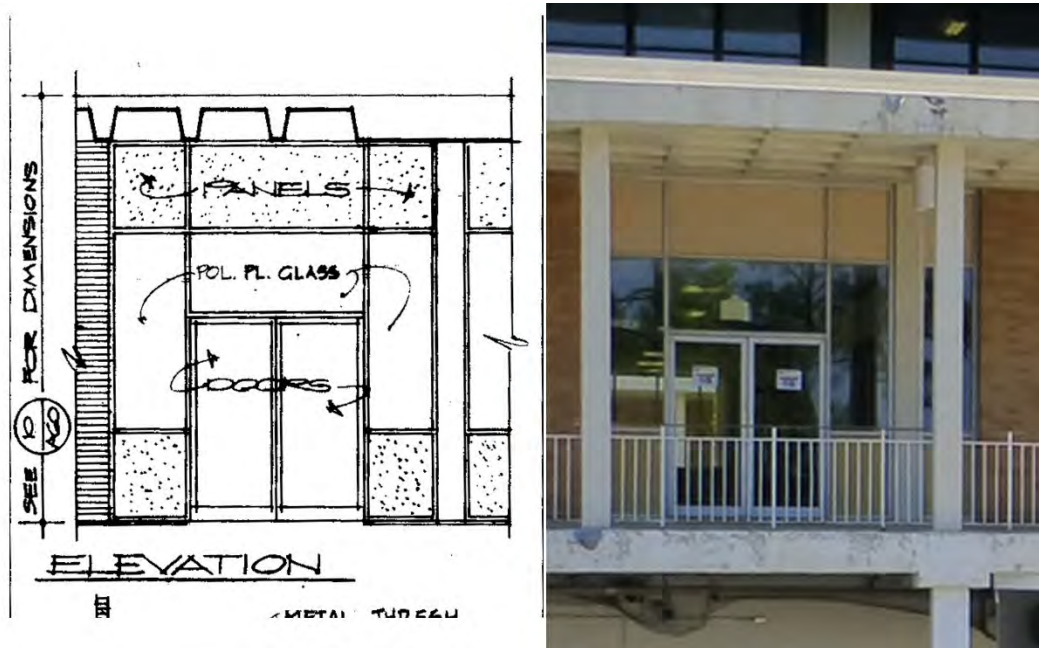
Figure 269. Entry bay for Building 29808, comparison of the original drawing detail from 1966 [left] to the current condition of the bright-aluminum and plate-glass doors and windows with insulated panels [right] (ERDC-CERL, 2015).

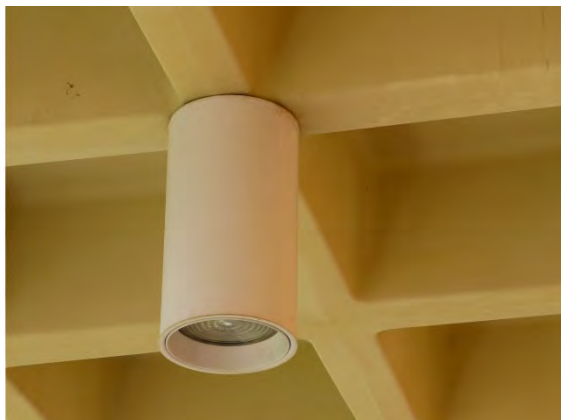
FIXTURE TYPE "G"
CEILING MOUNTED

Figure 270. Ceiling-mounted light fixture – comparison of the original drawing detail from 1966 [left] to the current condition of the ceiling-mounted light fixture under the concrete waffle canopy [right] (ERDC-CERL, 2015).

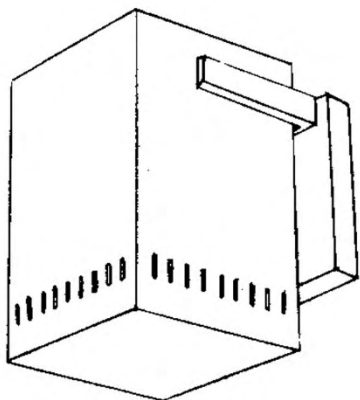
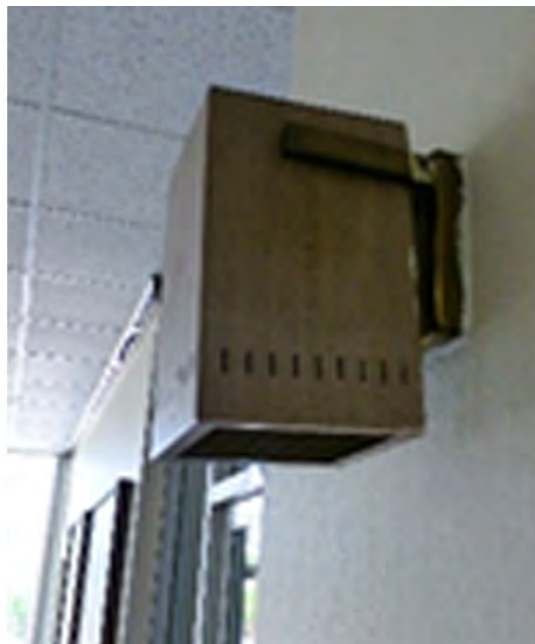
FIXTURE TYPE "AM"

Comparison images utilizing either the original drawings or historic photographs, when juxtaposed against present-day images, are a useful tool in developing the historic “feel” of a property and how much of that historic feeling is still present today. Figure 271 is an example of an original light fixture, but there are not enough of these left to have integrity of the original design (Figure 268—Figure 271).

Figure 271. Wall-mounted light fixture – comparison of the original drawing detail from 1966 [left] to the current condition of the wall-mounted interior light fixture [right] (ERDC-CERL, 2015).

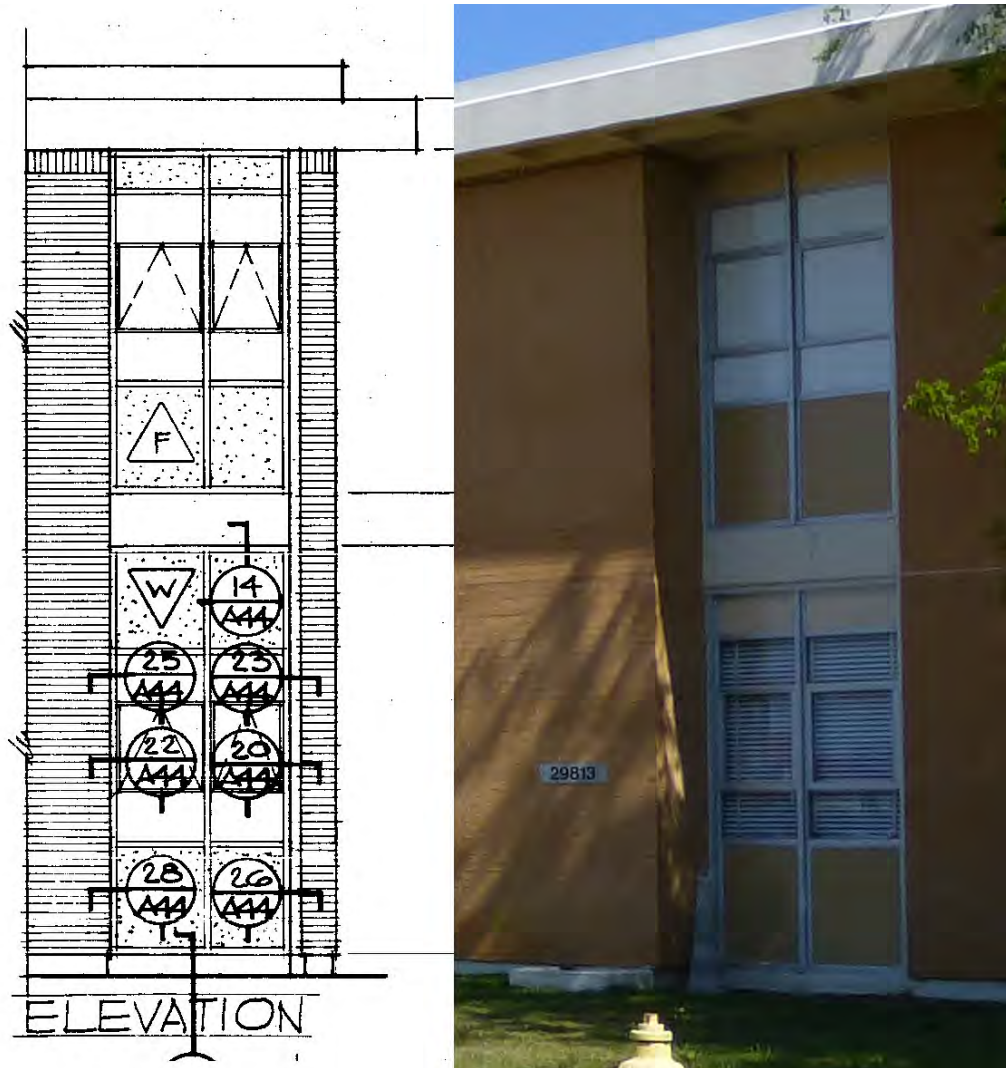
Figure 365. Doors on the east and west elevations – comparison of the original design and materials from 1964 [left] to the current condition of the metal doors with pane and transoms on the first floor and the metal and plate-glass doors with security bars on the second floor [right] (ERDC-CERL, 2015).

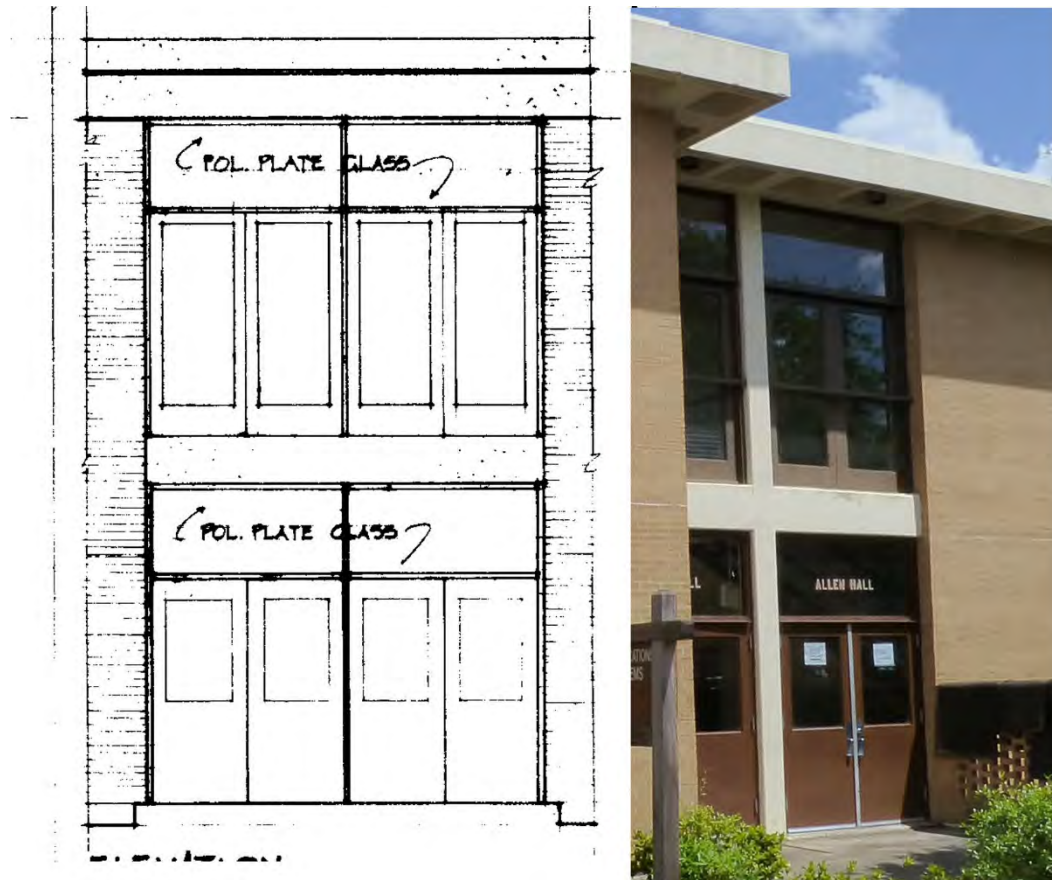
Figure 366. North wall of the right courtyard comparison of the original design and materials from 1964 [left] to the present-day [right] (ERDC-CERL, 2015).

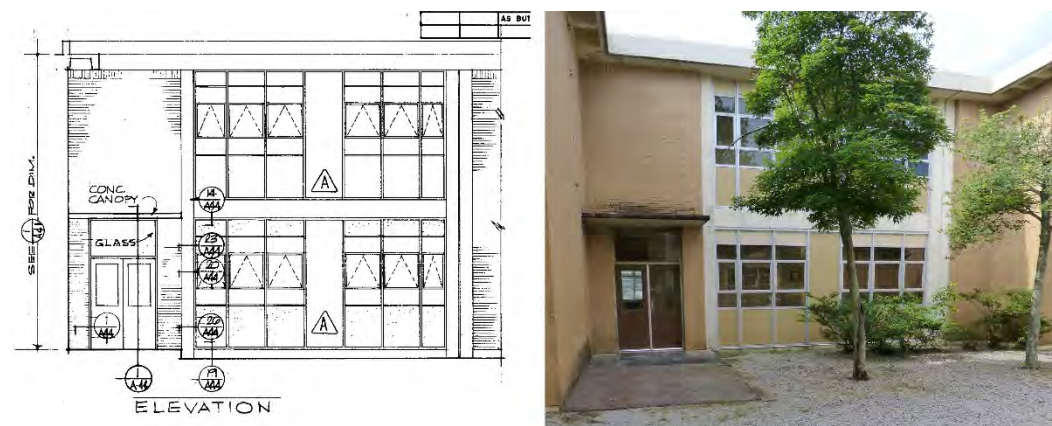
Figure 367. East and west walls of the courtyards – comparison of the original design and materials from 1964 [left] to the present-day [right] (ERDC-CERL, 2015).
